ARMY ENGINEER DISTRICT LOUISVILLE KY  
SOUTHWESTERN JEFFERSON COUNTY, KENTUCKY. LOCAL FLOOD PROTECTION--ETC(U)  
APR 82

REPORT DOCUMENTATION PAGE		READ INSTRUCTIONS BEFORE COMPLETING FORM
1. REPORT NUMBER	2. GOVT ACCESSION NO.	3. RECIPIENT'S CATALOG NUMBER
	AD-A115680	
4. TITLE (and Subtitle) Supplement No. 5: Southwestern Jefferson County, Kentucky--Local flood protection project.		5. TYPE OF REPORT & PERIOD COVERED Foundation Report

17. ABSTRACT (Continue on reverse side if necessary and identify by block number) Results of inspections at three pumping station construction sites in Southwestern Jefferson County, Kentucky.

Volume I - Foundation at Riverport, Lower Mill Creek  
and Upper Mill Creek Pumping Stations

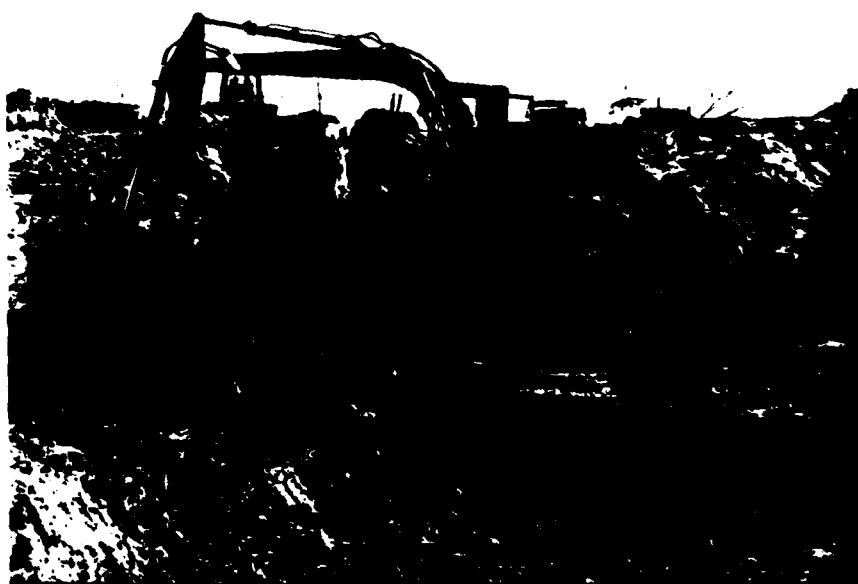
East Side Excavation at Elevation 388.0  
UPPER MILL CREEK PUMPING STATION

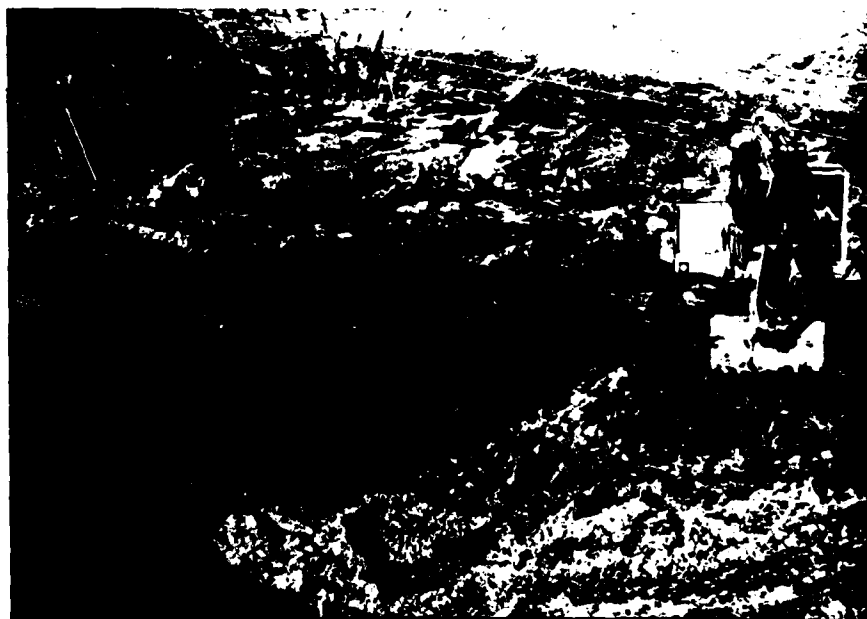
a. Upper Mill Creek - When the contractor had excavated to elevation 388 on 6 November 1981, it became apparent by visual observation that the silty clay had not been removed over the entire foundation area. Approximately one-third of the foundation on the south side of the pump plant was acceptable; the clay had been completely removed and the in-situ pervious sand had been exposed. On the north side of the foundation, large seams or lenses of the clay were randomly interspersed in the sand. Some test pits were dug and it was determined that as much as five or six more feet of the clay lenses would need to be removed to expose the sand. The clay lenses were removed by modification to the contract and refilled with sand from the borrow area. Personnel from the Resident Office, District Office Construction Division and Engineering Division Geotechnical Branch inspected the foundation after the clay lenses were removed and agreed that the in-situ sand had been exposed over the entire foundation area as was originally intended. Details of the excavation below elevation 388 are shown on Plate Number 9 and in the photographs in this supplement.

Northwest Corner Excavation Undercut Below Elevation 388.0  
UPPER MILL CREEK PUMPING STATION

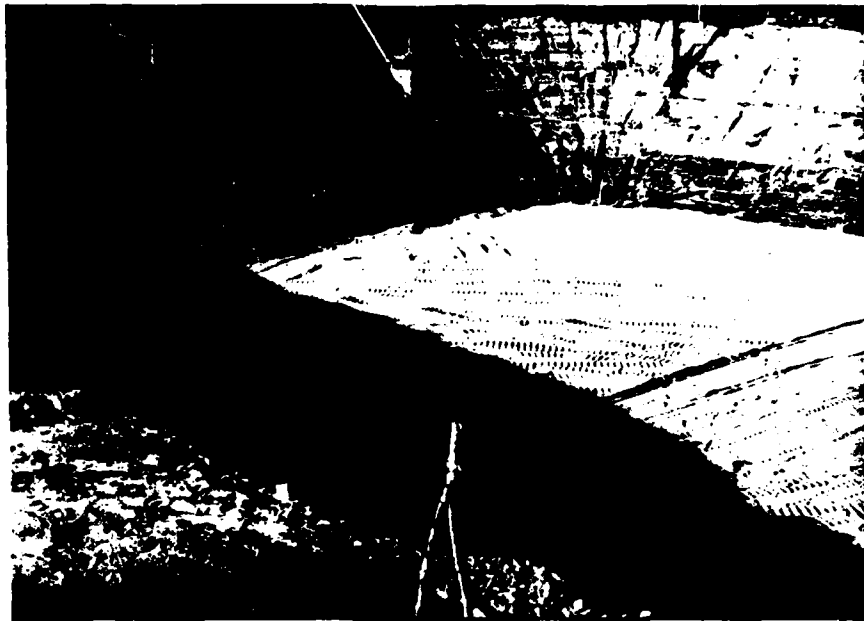
Stone Filter for Drainage System  
UPPER MILL CREEK PUMPING STATION

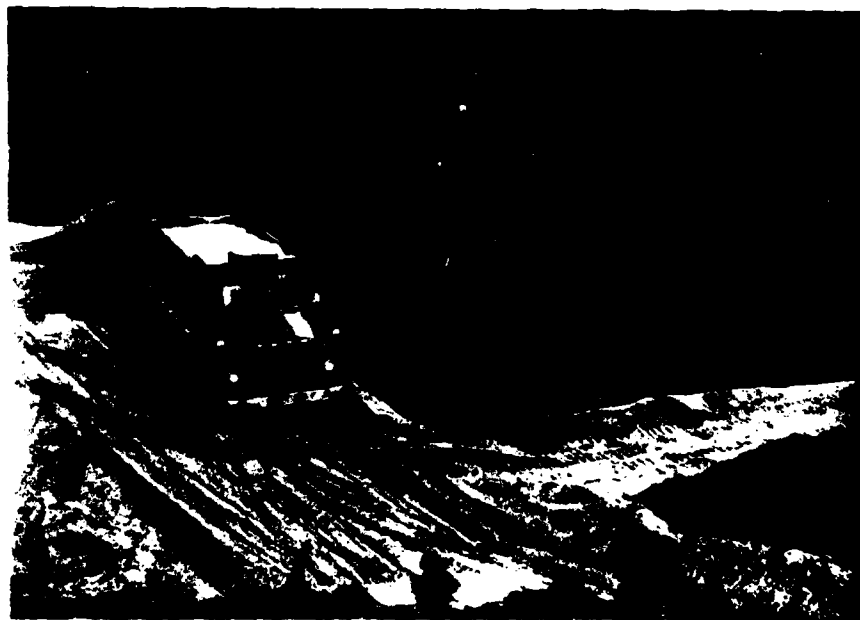
Northwest Corner Installation of Stone Filter Material  
UPPER MILL CREEK PUMPING STATION

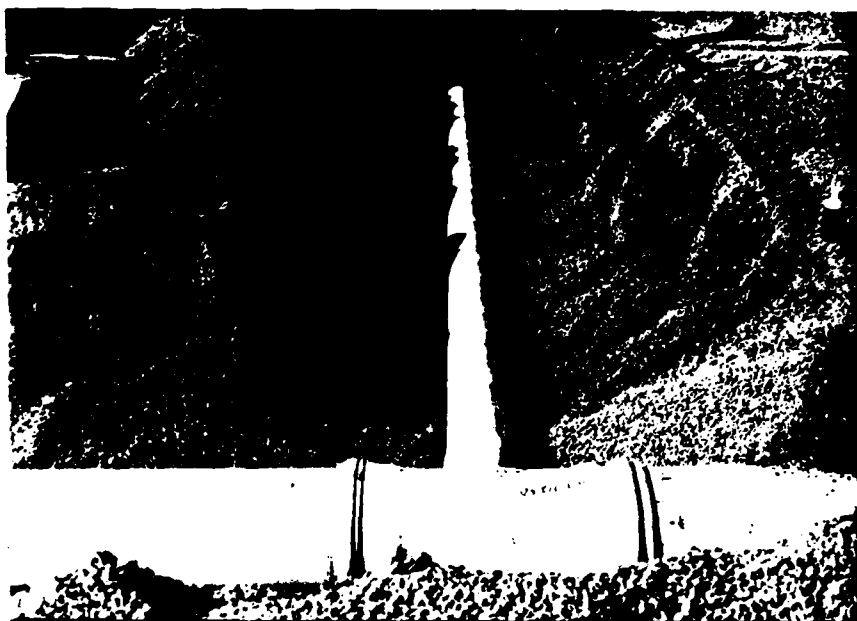
Looking West Installation of Lateral Drains  
UPPER MILL CREEK PUMPING STATION

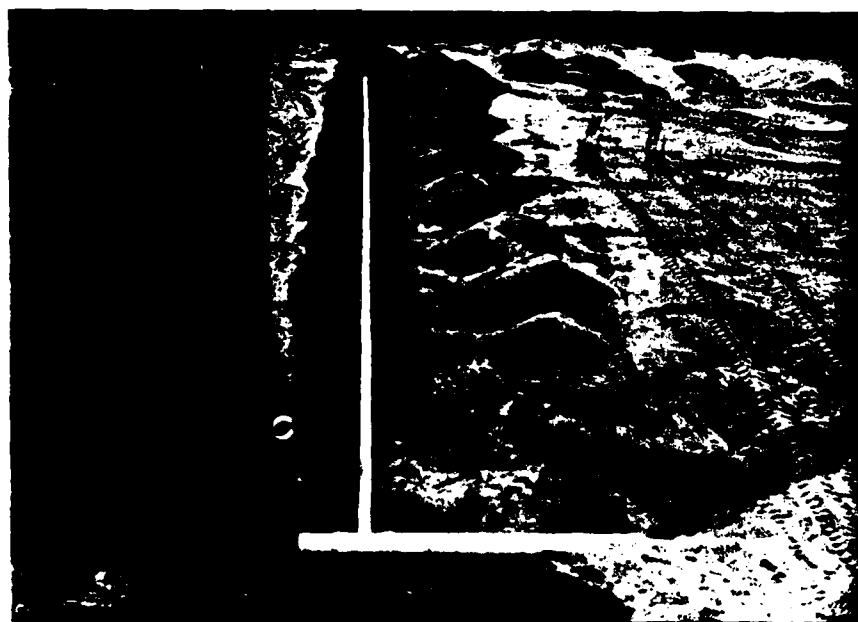
Installation of Lateral Drains  
UPPER MILL CREEK PUMPING STATION

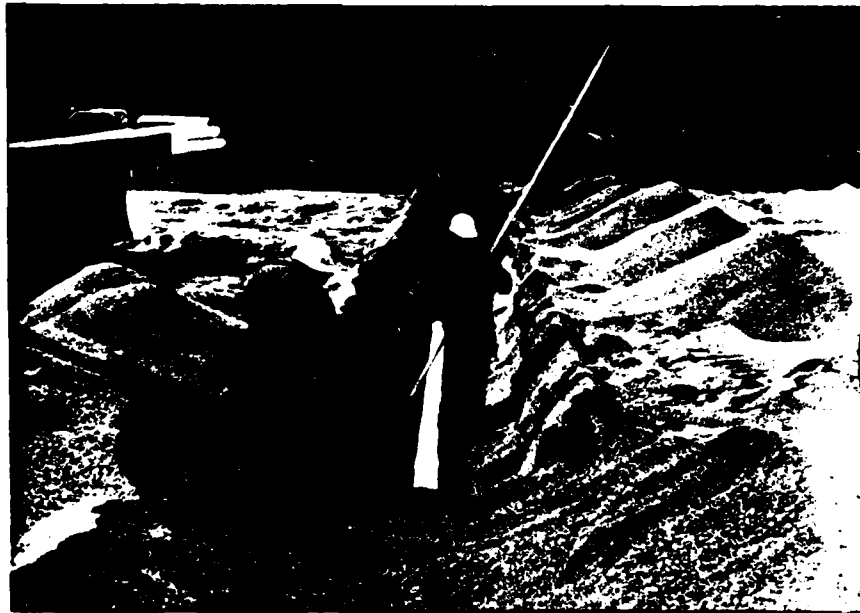
Installation of Lateral Drains  
UPPER MILL CREEK PUMPING STATION
